Managing Historic Wrecks

The RFA Darkdale

Polly Hill, Salvage and Marine Operations, Ministry of Defence, UK

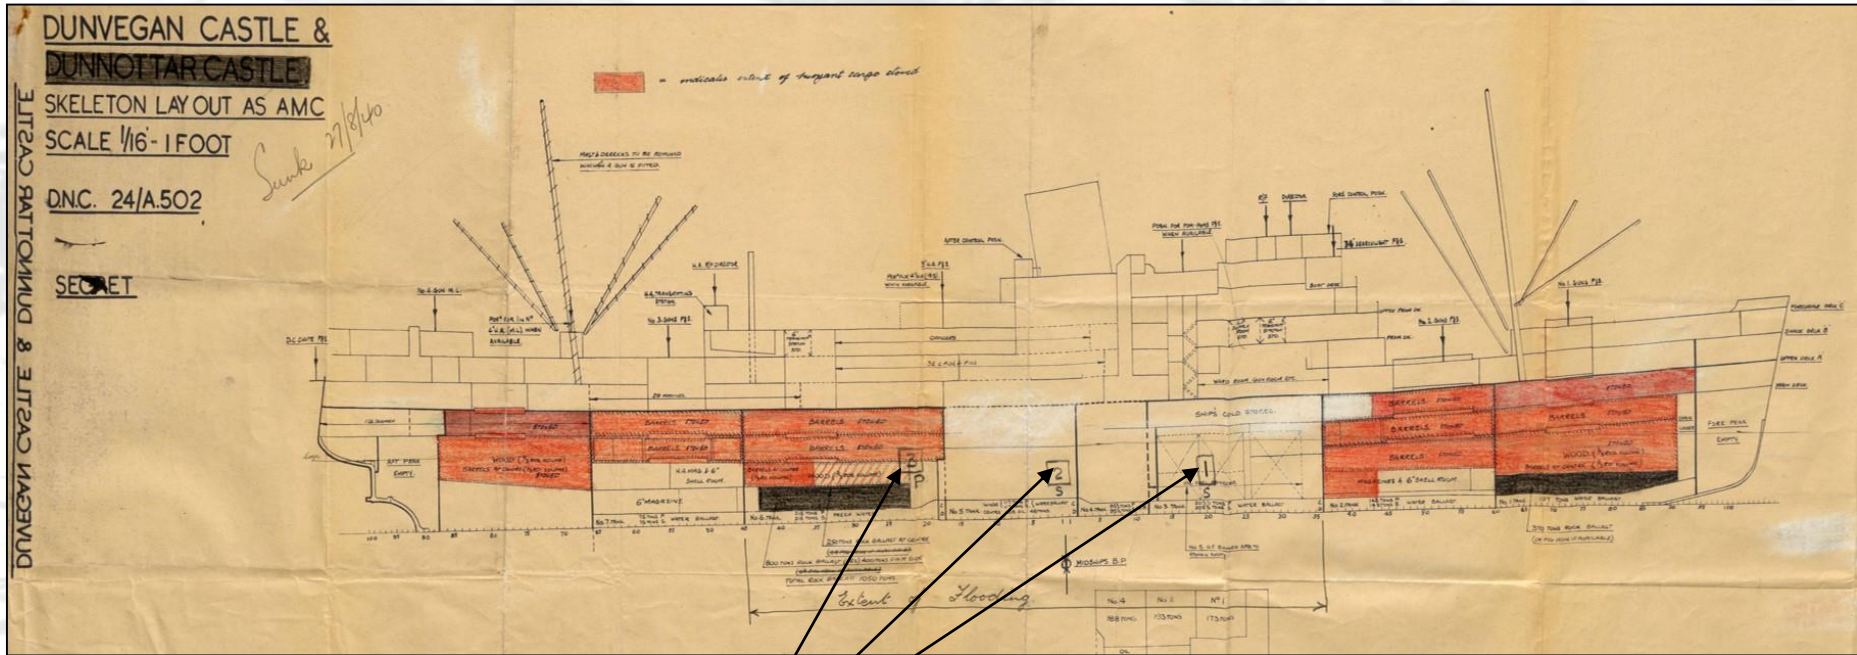
Location of the torpedo hits that caused the loss of HMS *Dunvegan Castle*

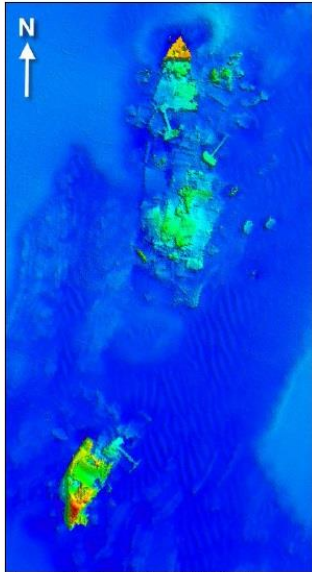
Figure 2 - Plan view of Wreck 22682 DTM.

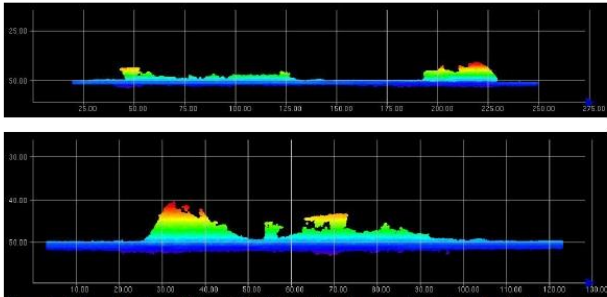
Figure 4 - Orthometric views of Wreck 22682 viewed from the west side (top) and south (bottom).

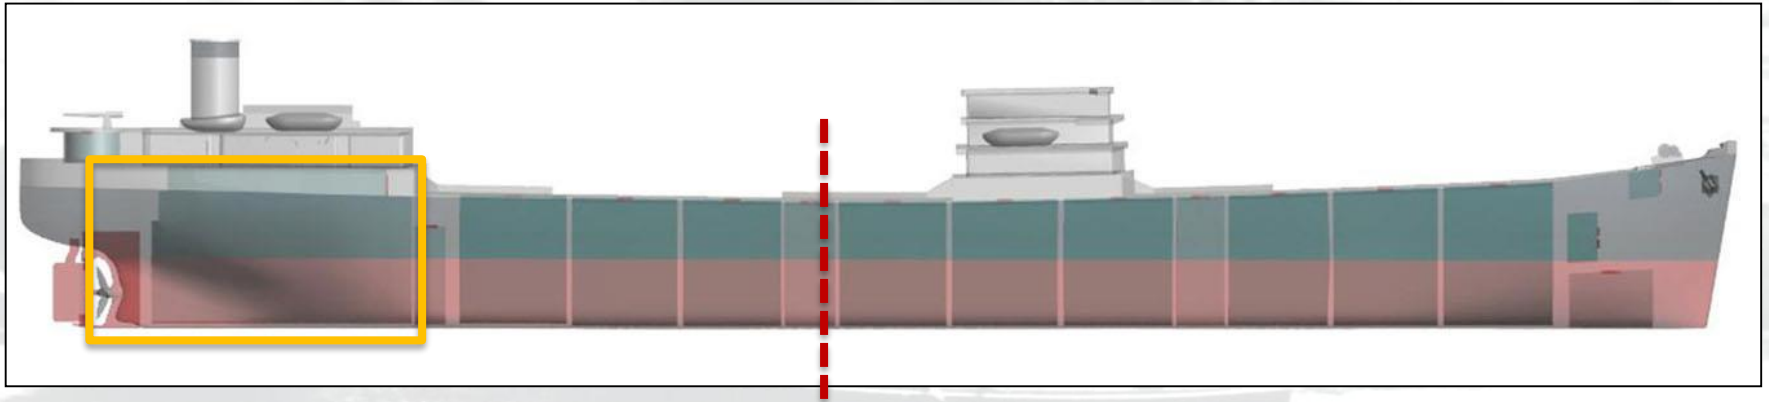
- Engine room likely to have torpedo damage to port side
- Mainly intact plating on starboard side will trap small residual quantities of oil

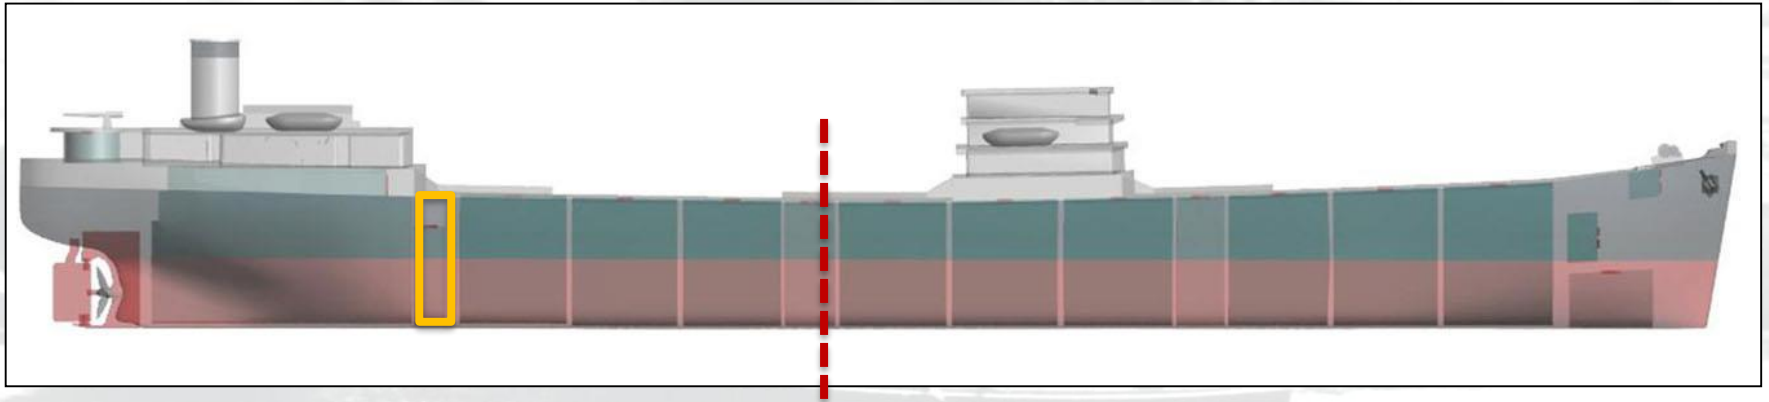
- Bunker tanks likely to contain some oil
- Most likely source of leak in 2010

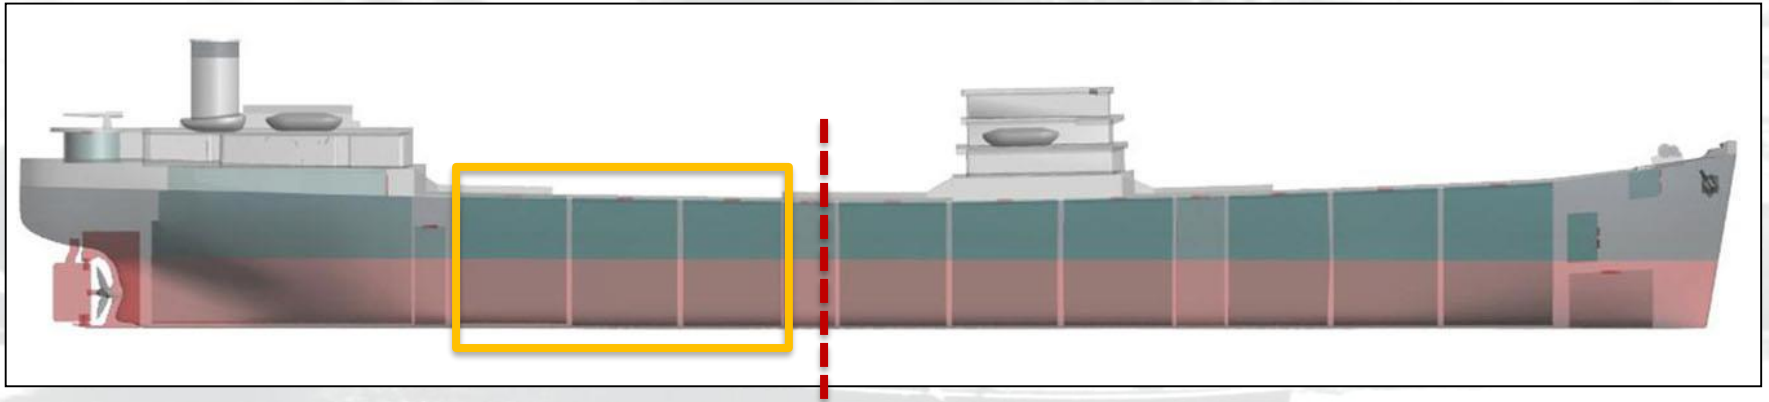
- Badly torpedo damaged
- Cargo tanks 1 to 3 open to the sea; no significant oil content

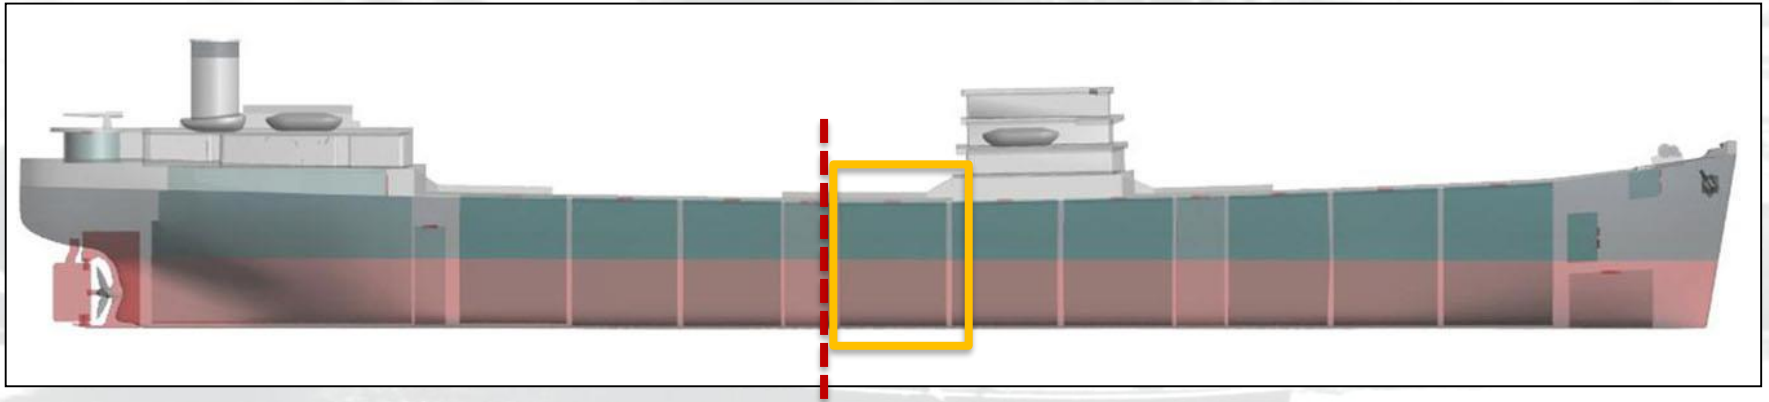
- No. 4 Cargo tank partially open to the sea but known to contain some oil
- Estimated to be circa 150m³

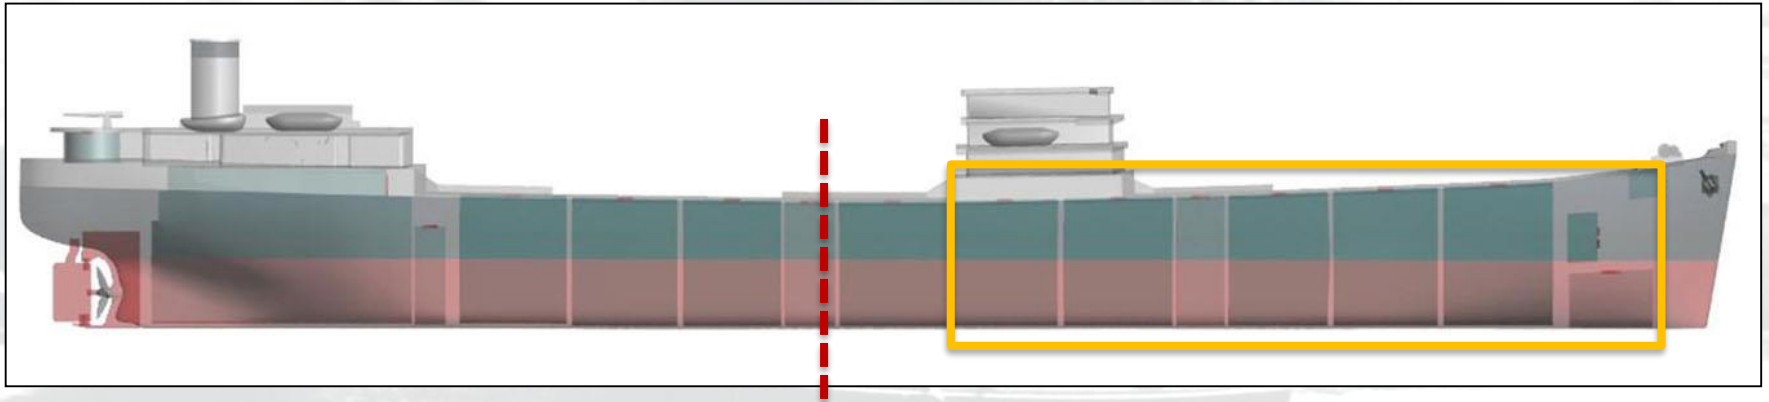
- Cargo tanks 5 to 9 intact
- Estimated quantity of oil remaining onboard 2800 to 4500m³
