MV Fedra

10 October 2008

MV Fedra was a Liberian-registered bulk-carrier cargo ship. It ran aground and smashed against Europa Point, the southernmost tip of Gibraltar, on the 10 October 2008, following severe gale force winds measuring 12 on the Beaufort scale.

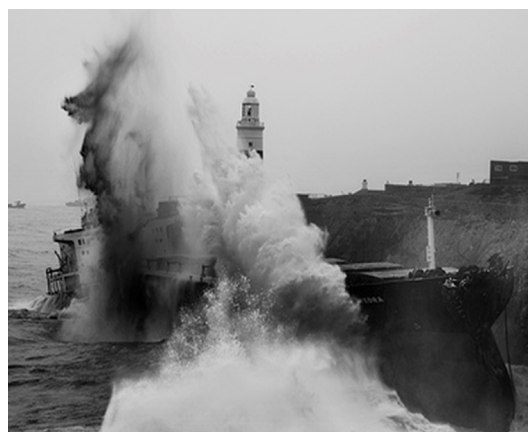
First light allows initial assessment of the incident. MV Fedra has broken her back just forward of the engine room bulkhead. The stern section, carrying an estimated 300 tonnes of Heavy Fuel Oil (HFO) & 50 tonnes of diesel in wing tanks, is being pushed on to the rocks.
