Managing Historic Wrecks

The RFA Darkdale

Polly Hill, Salvage and Marine Operations, Ministry of Defence, UK

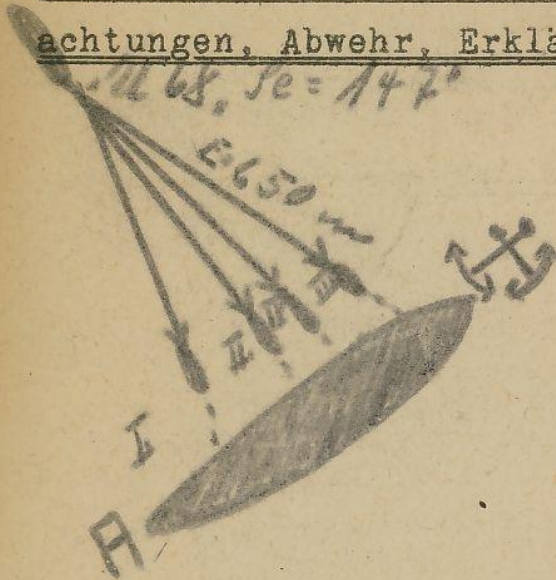
Ziel war vor Anker liegender Tanker von 8100 t. Tanker mußte unter allen Umständen sofort und restlos vernichtet werden. Dahernach den vorherigen ungeklärten Schüssen 4 Torpedos mit Schußwinkel 0.
